Capital Reserve Analysis Inman Park Pool Association, Inc.

G & M Engineering, Inc.

May 2025

Property Description

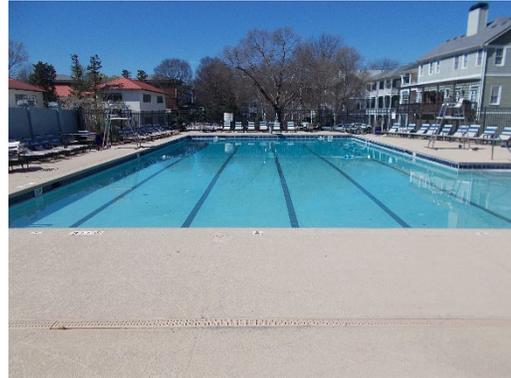
Swimming Pool and Kiddie Pool - The swimming pool and kiddie pool were observed to be in good condition. The reserve budget to resurface the pool is \$40,000 every 10 years and \$10,000 for water line tiles every 20 years. We have included this budget in the reserve analysis for 2032. We have also included numerous other budgets in the reserve analysis for the pool area to include: repair to the concrete pool deck, replacement of the pool furniture, repair and painting of the pool fence, and the replacement of the pool equipment. There are separate budgets for the wading pool for replacement of the plaster. All the budgets are based upon the conditions observed at the pool area during our review.

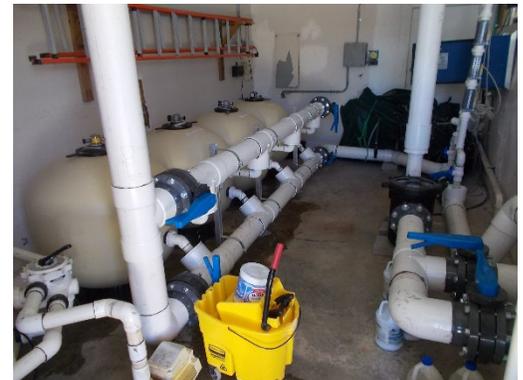
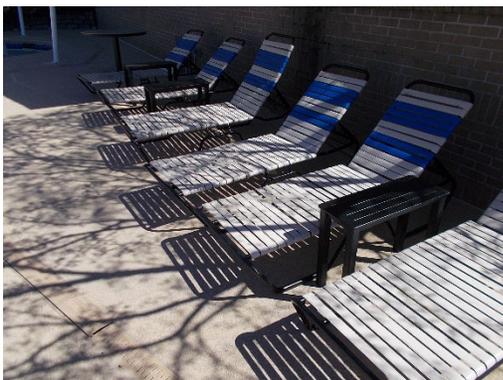
The pool equipment was functioning at the time of our review. The operation of the pool was getting started for the season. The pool equipment typically will require some type of repair at the beginning of each season. We have included a budget to replace all the pool equipment during a five-year cycle. This allows funds to be provided within the reserve when each season a pump goes out or valve requires replacement. The budget for the pool equipment is \$8,000 every five years.

The pool furniture was observed to be in good condition. The budget for the pool furniture is designed to provide funding for a complete replacement of the furniture every eight years. We understand that some communities will prefer to install new strapping at the chair

frames and continue with utilization of the same furniture; however, it has been our experience that the funding levels should not be adjusted for this method of furniture usage. The budget provided is \$10,000 every eight years beginning in four more years.

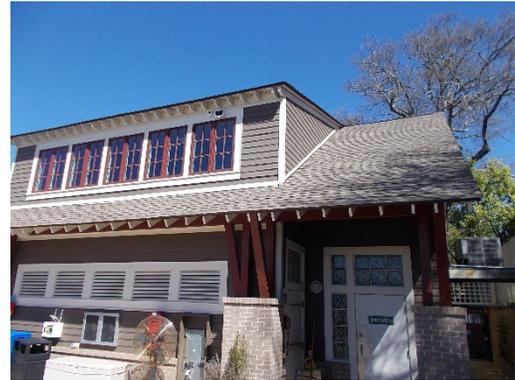
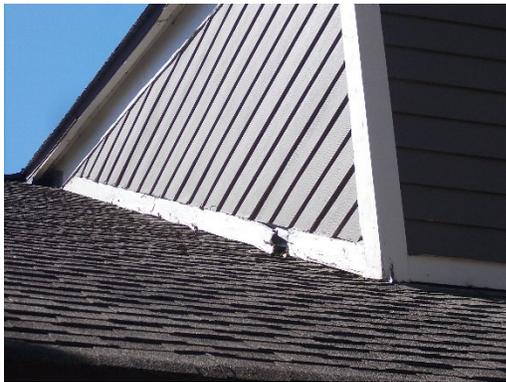
Clubhouse - The poolhouse consists of a single-story wood-framed structure constructed over a cast-in-place concrete slab. The exterior veneer consists of composite siding with wood trim and brick accents. The roof consists of a steep sloped roof structure clad with roof decking and asphalt shingles. The condition of the shingles was approaching the end of their useful life. We have included in the budget \$375 per square of shingles and an estimated size of 29 squares of shingles for the roof. This provides a budget of approximately \$11,000 to replace the

roof next year. We have included multiply other budgets for the clubhouse to include interior and exterior painting, remodeling the bathrooms, replacement of the HVAC system and refinishing the flooring. The overall condition of the clubhouse was observed to be good, however; we did observe locations of deteriorated wood trim at the front of the pool house roof.
